Proposed Works to the Church of the Immaculate Conception, Kingscourt, Co. Cavan.

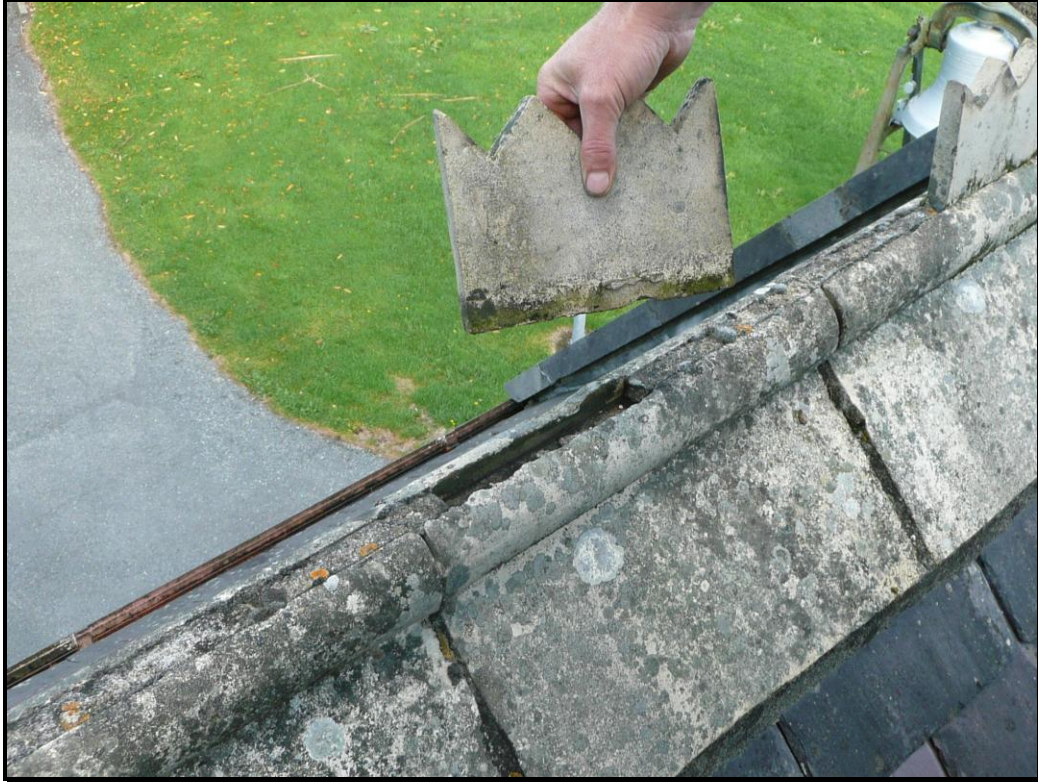
Loose decorative pieces top ridge capping

1. Replace of Existing Roof Slates, Battens, Felt, Lead and Ridge Capping

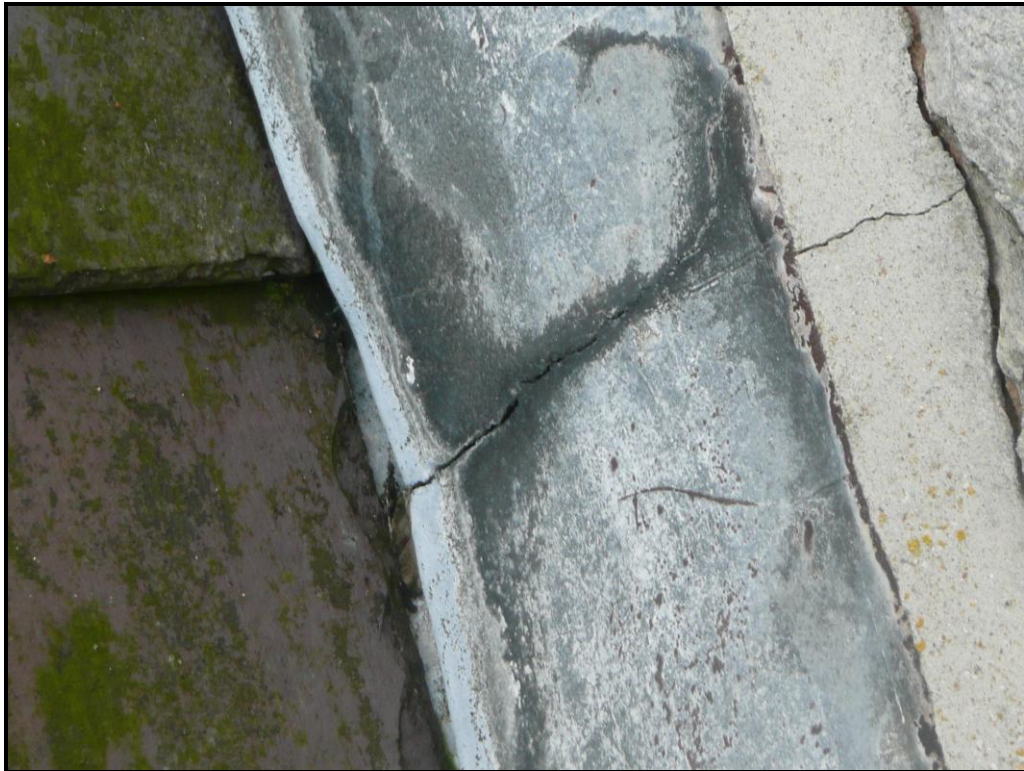
Cracked lead flashing to south eastern elevation of nave

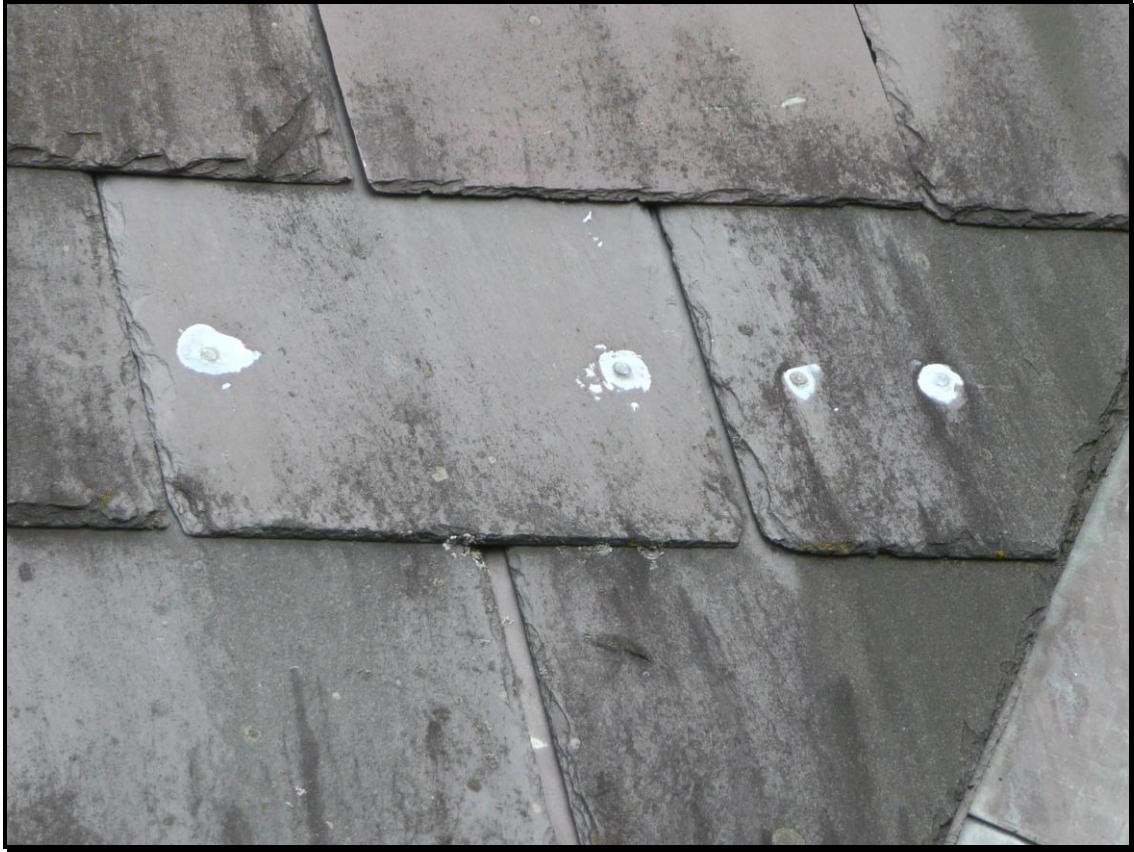
Slates repaired with nails and sealant

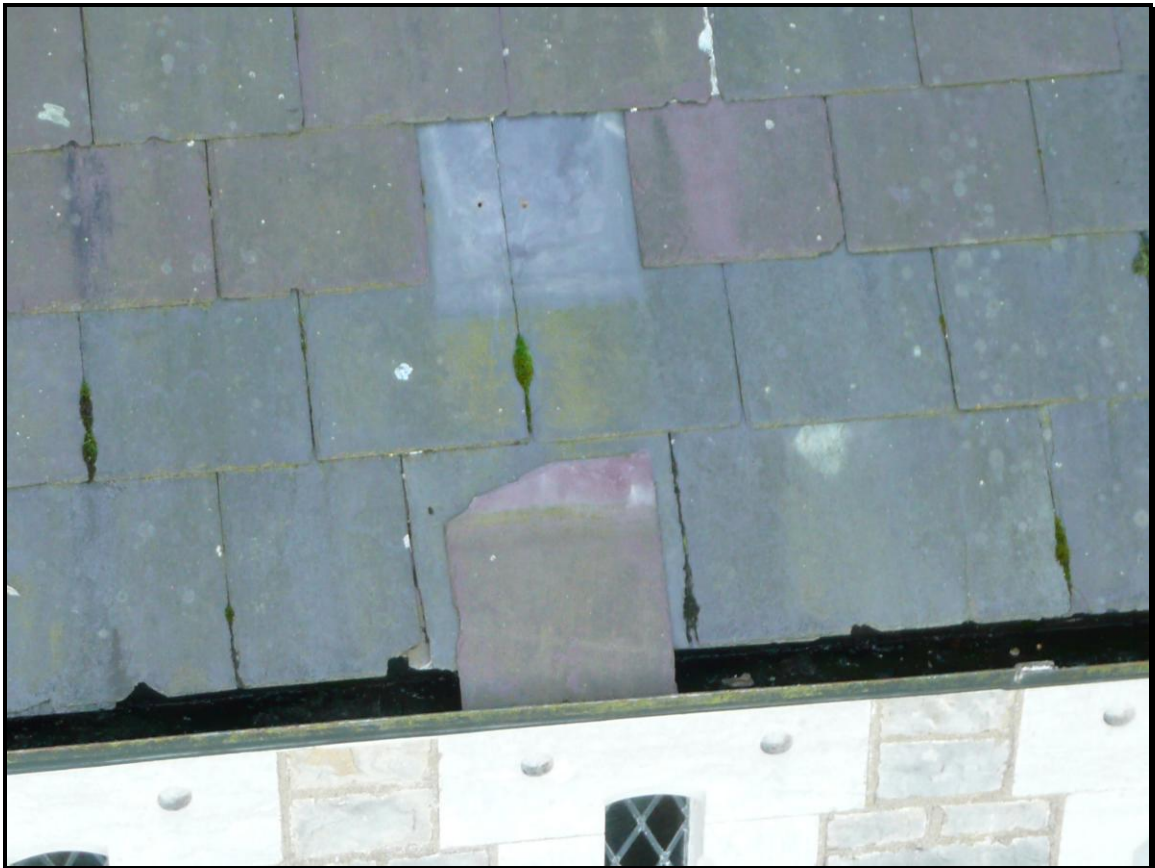
Dislodged slate

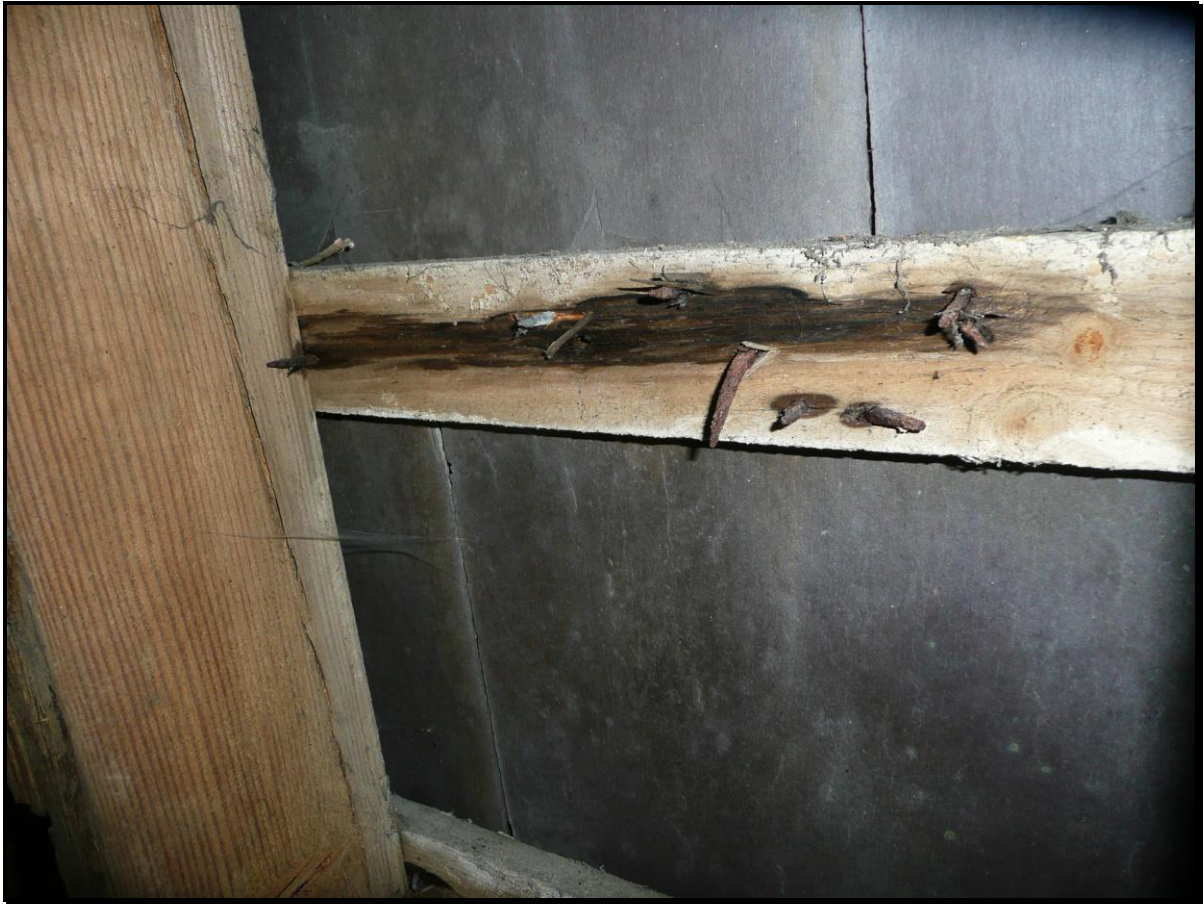
Corroded slate fixings and decayed batten

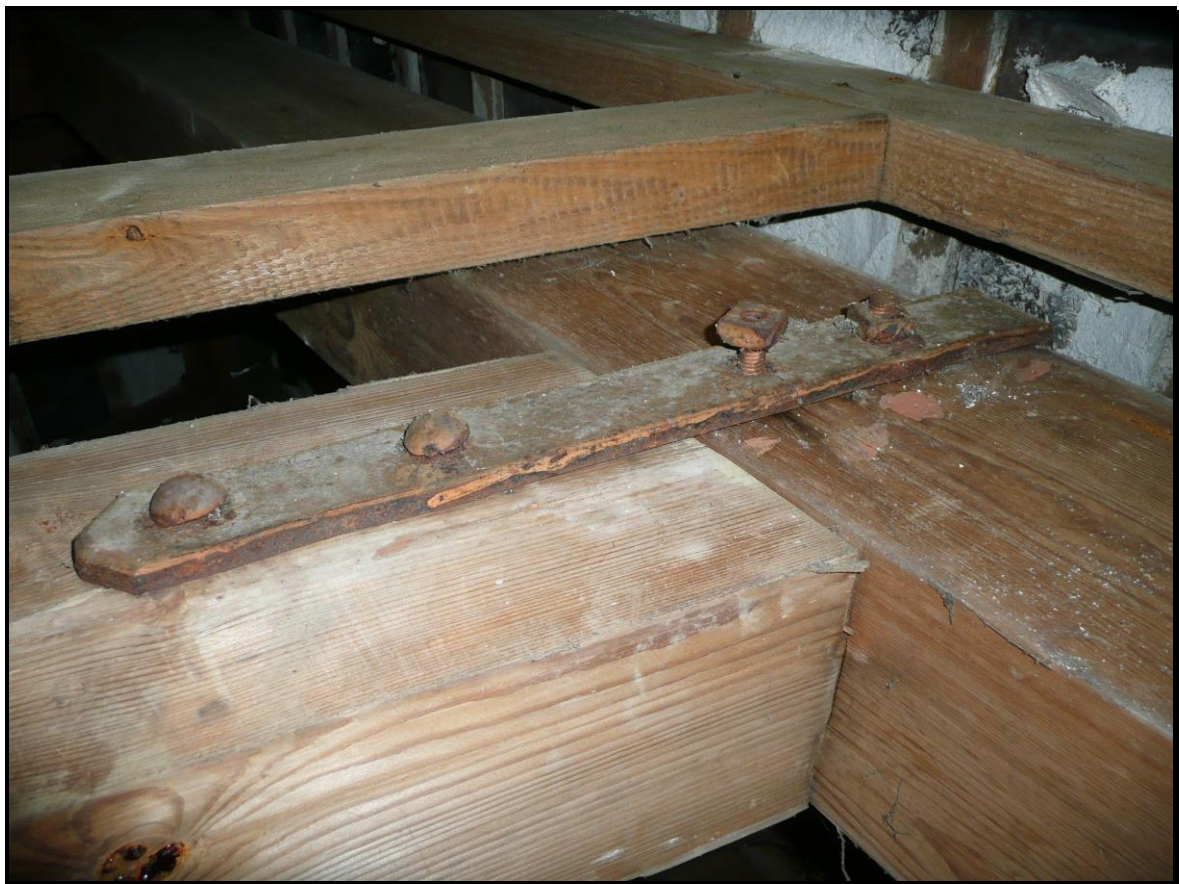
Corrosion and loose bolts in truss straps

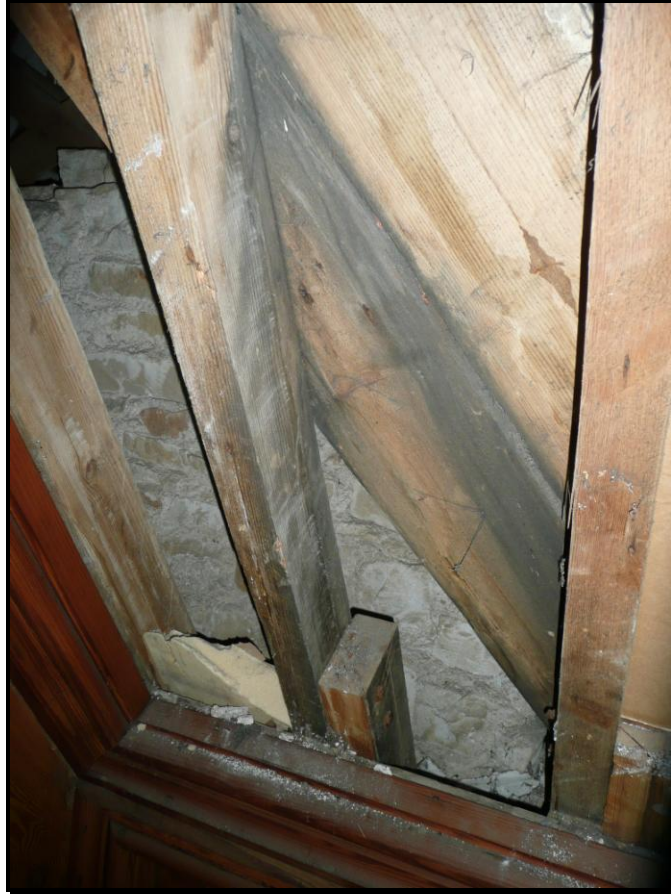
Water staining on valley boards and rafters between nave and south transept

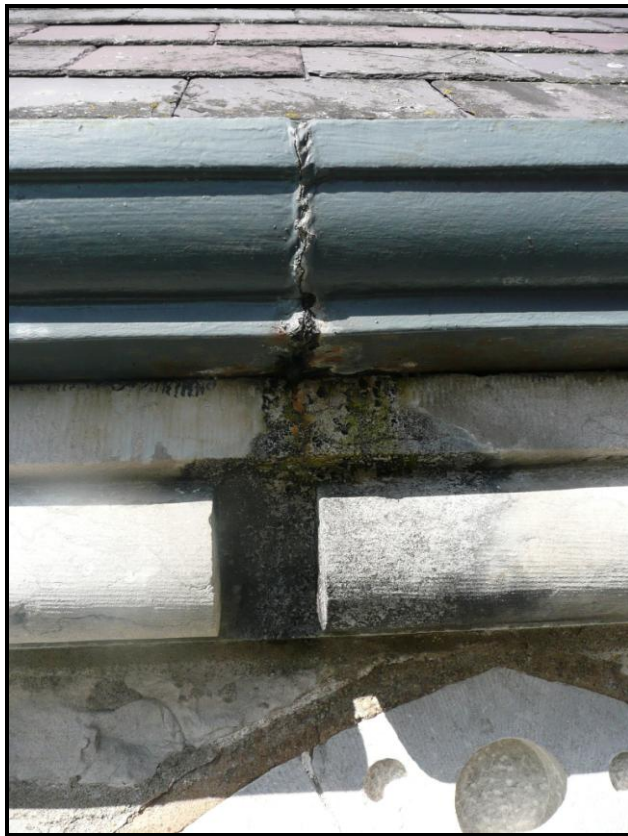
Leak at joint in gutter

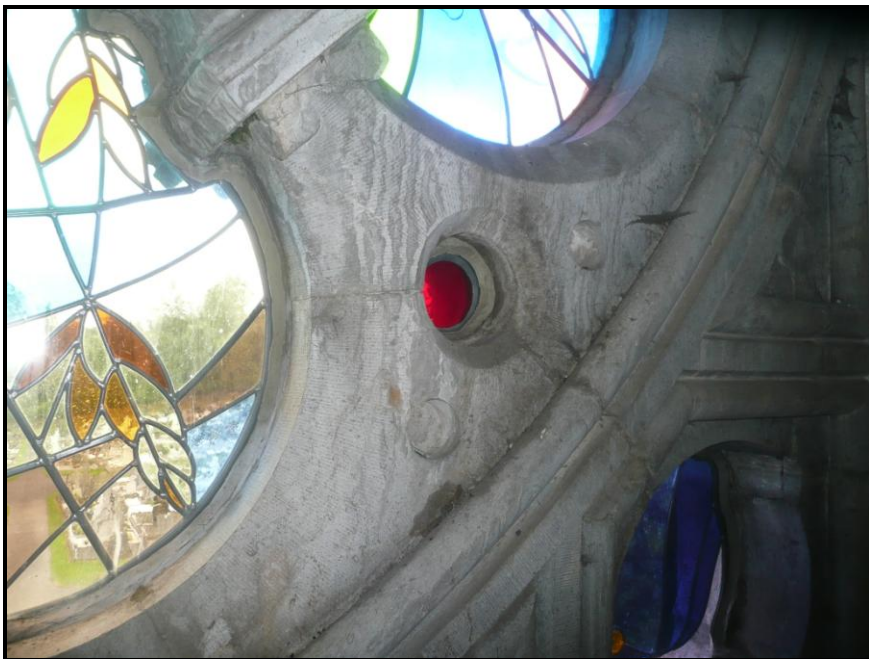
Water staining on stone window surrounds

2. Restoration to Existing Stained glass windows / Gable Rose window.

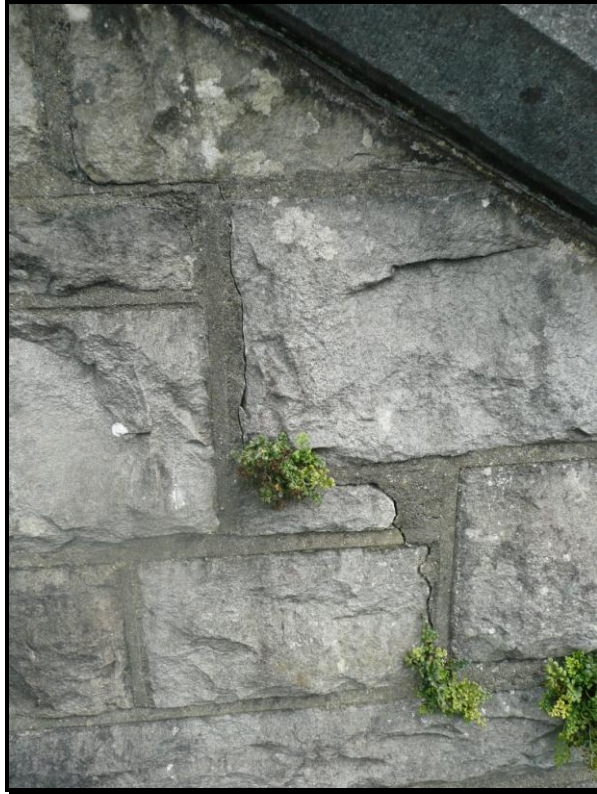
Cracked joints to masonry on west elevation

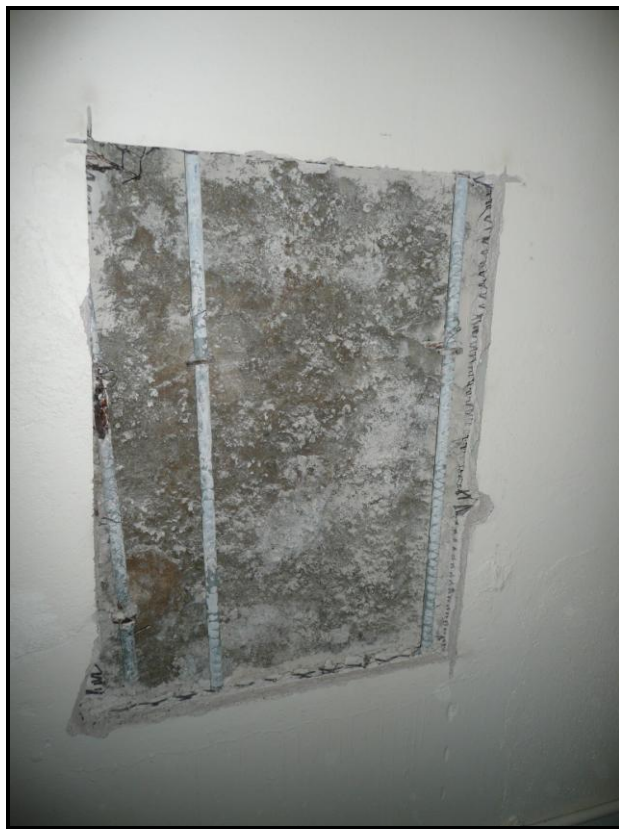
Dry-lined plaster to internal face of rear (west) wall

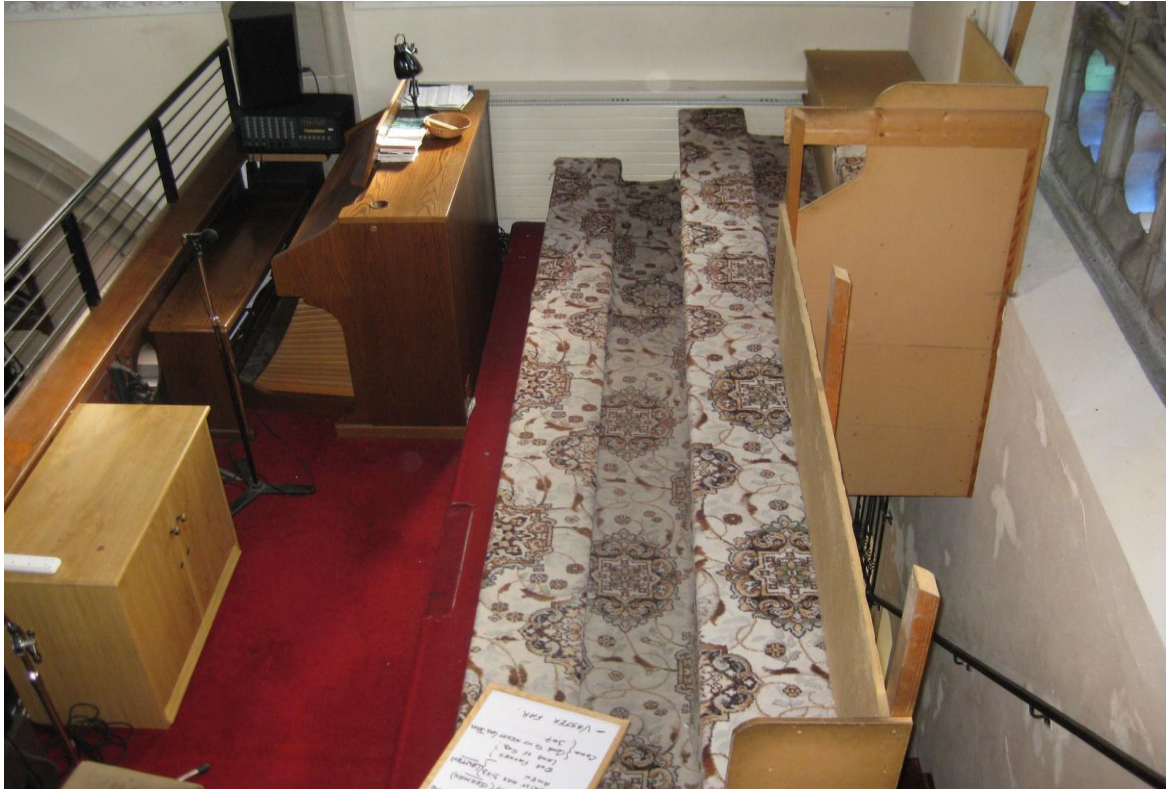
Existing First Floor Gallery – Inadequate/Unsafe Railings

5. Alterations and Up-Grade Existing Internal Gallery

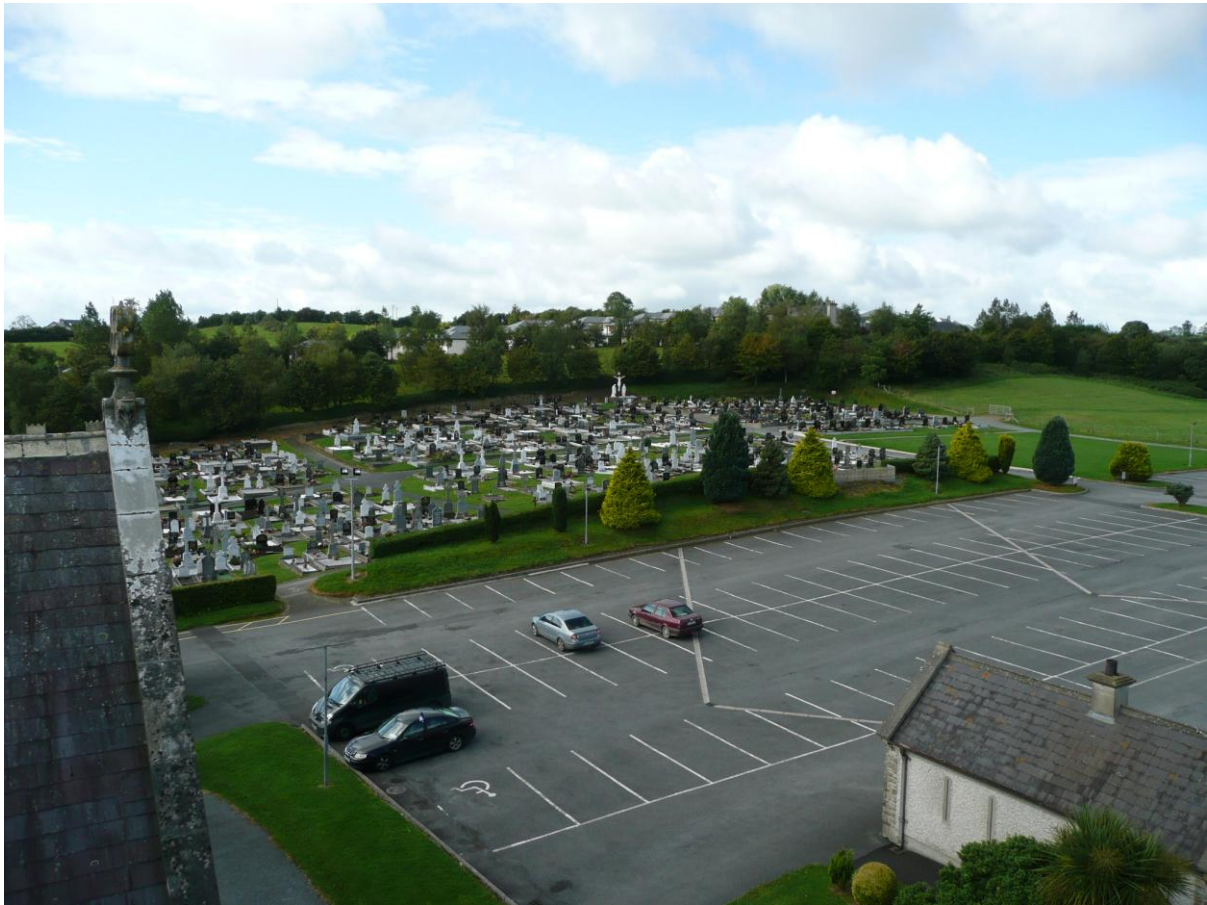
Existing Carpark Area to be Re-Surfaced

9. Re-Surfacing Existing Carpark and access roads

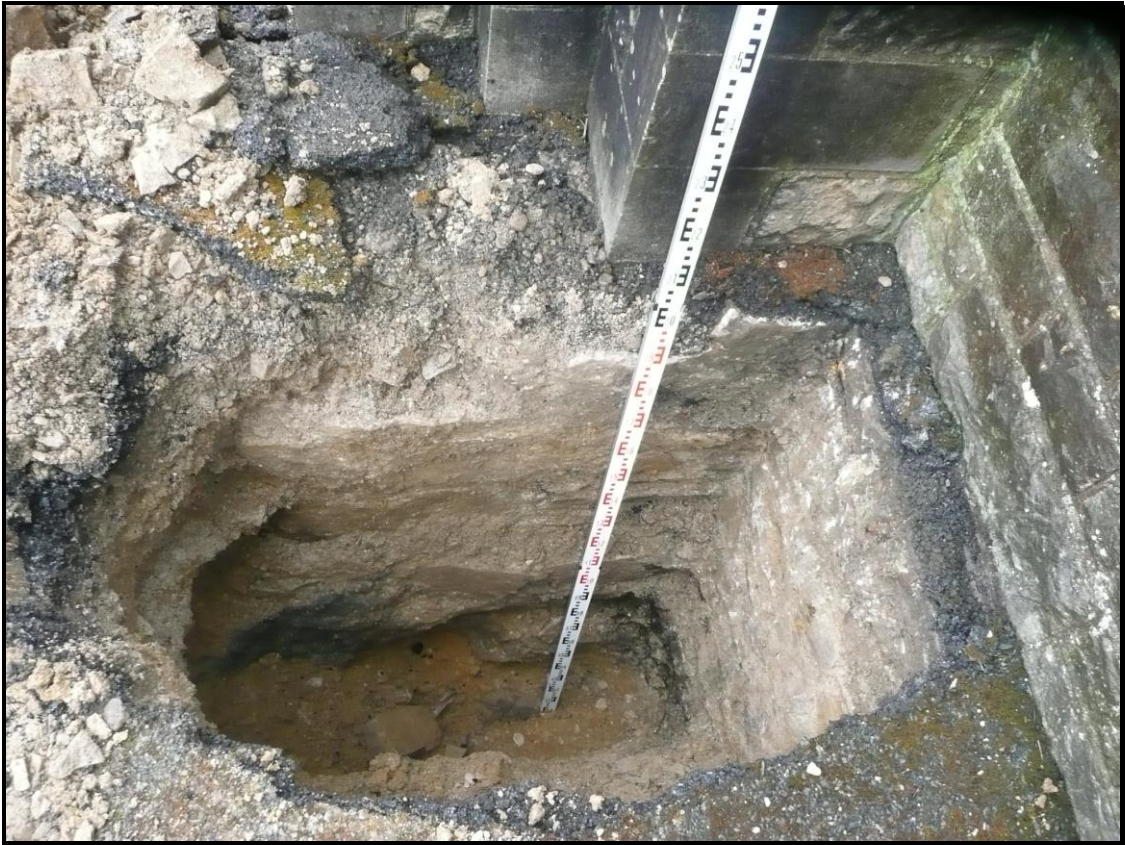
A geotechnical investigation was carried out by Alan Clarke Engineer at the foundation level of the existing bell tower. This site investigation revealed substantial deep foundations below the existing tower supported on firm subsoils. The foundations and general structural arrangement of the tower indicate that the original structure was built with the intention of supporting a full tower and spire.

Trial pit excavated at northern corner of belltower

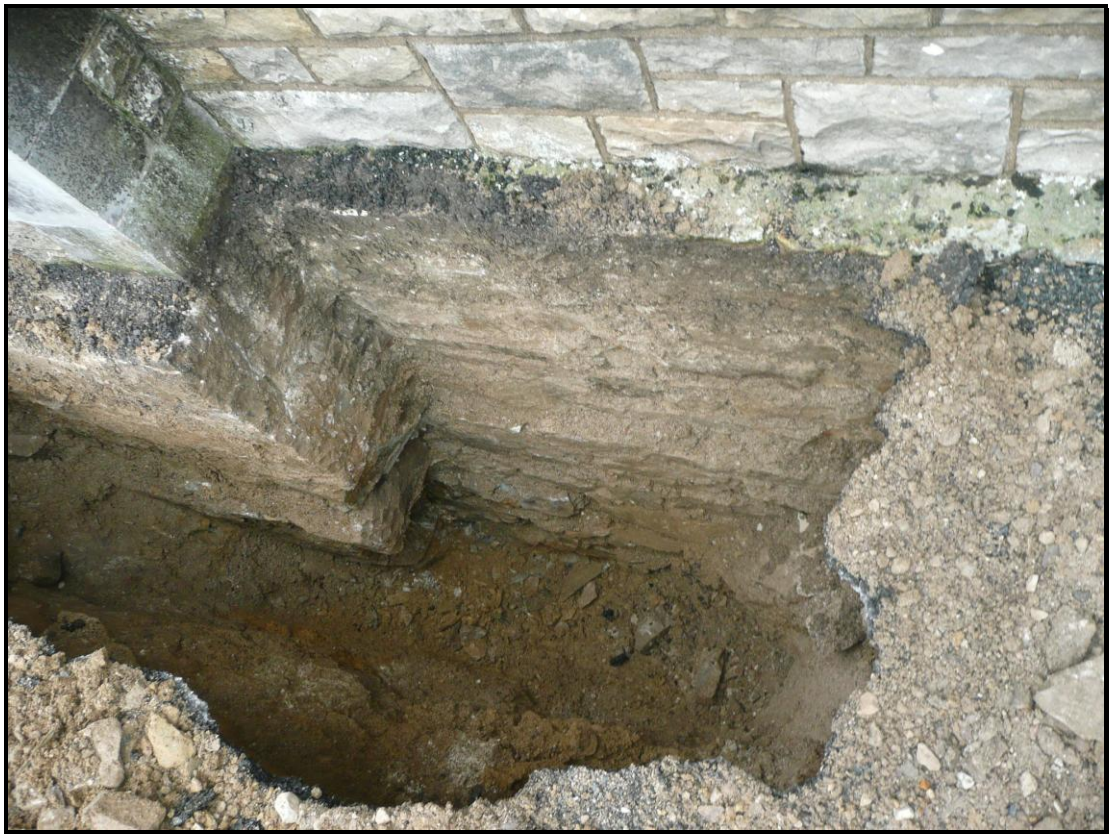
Trial pit excavated at southern corner of tower
