Proposed Works to the Church of the Immaculate Conception, Kingscourt, Co. Cavan.

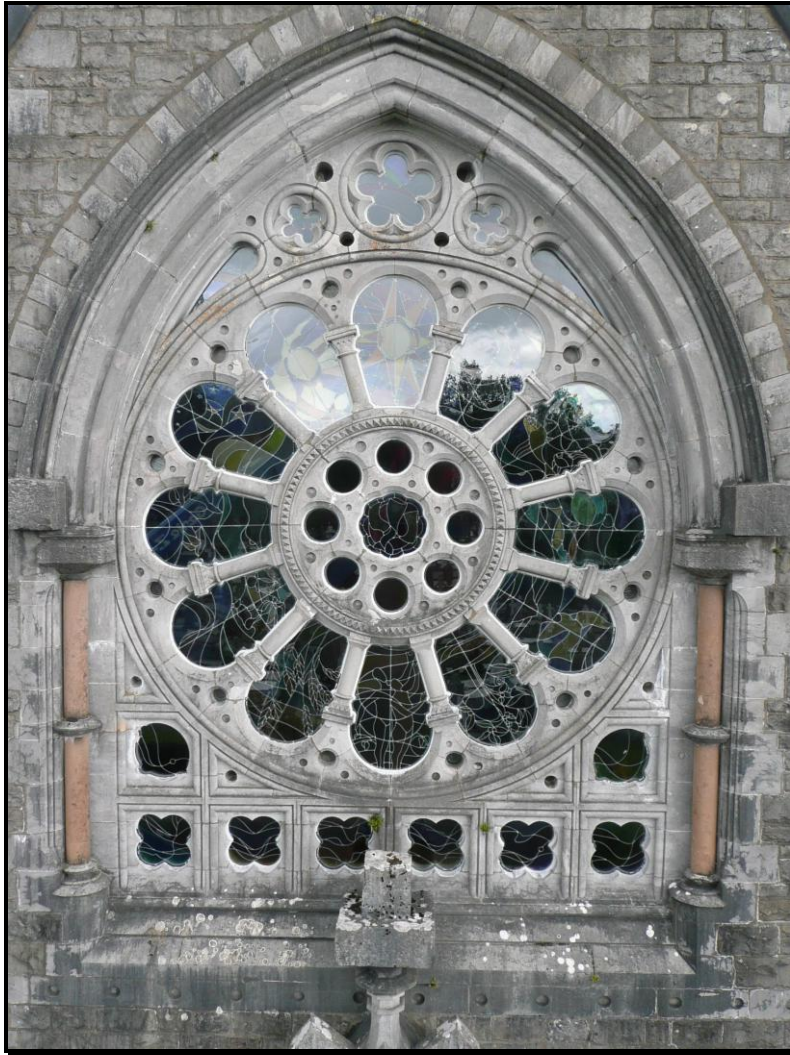
Existing Rose Window

2. Restoration to Existing Stained glass windows / Gable Rose window.

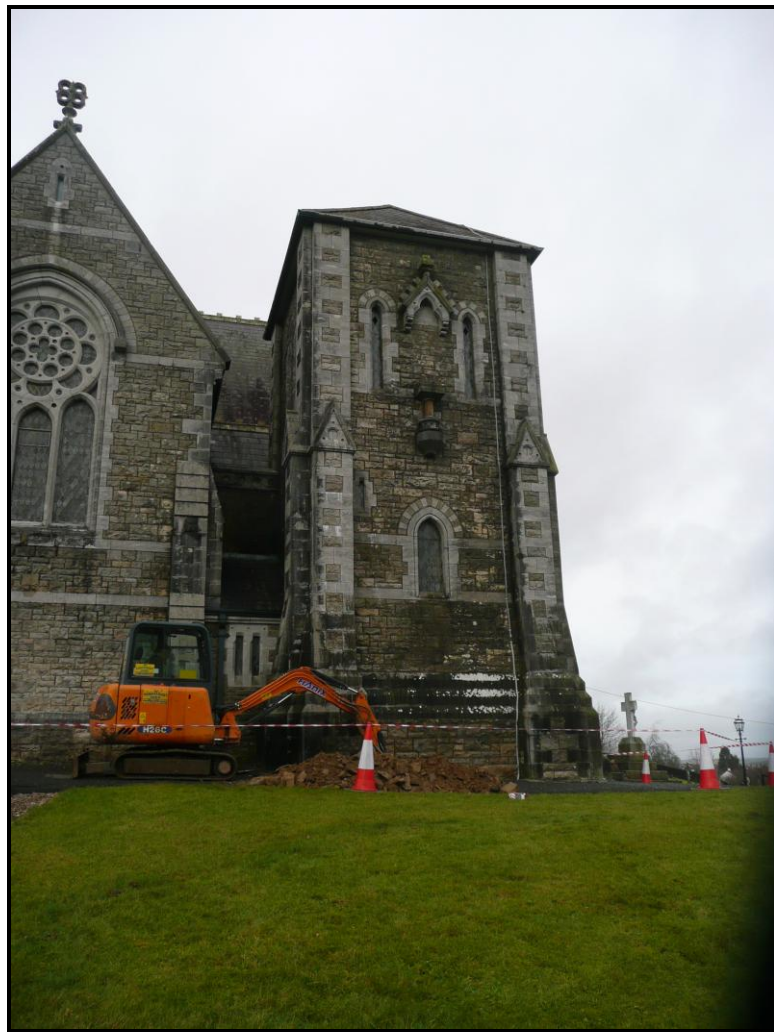
A geotechnical investigation was carried out by Alan Clarke Engineer at the foundation level of the existing bell tower. This site investigation revealed substantial deep foundations below the existing tower supported on firm subsoils. The foundations and general structural arrangement of the tower indicate that the original structure was built with the intention of supporting a full tower and spire.

View of Bell tower from South East side

Proposal - Extend existing stone structure to complete bell tower and spire, insert statues into existing recesses
